Name Of Dam: UPPER BLACKWATER NO. 4

Location: FRANKLIN COUNTY, VIRGINIA

PHASE I INSPECTION REPORT

NATIONAL DAM SAFETY PROGRAM

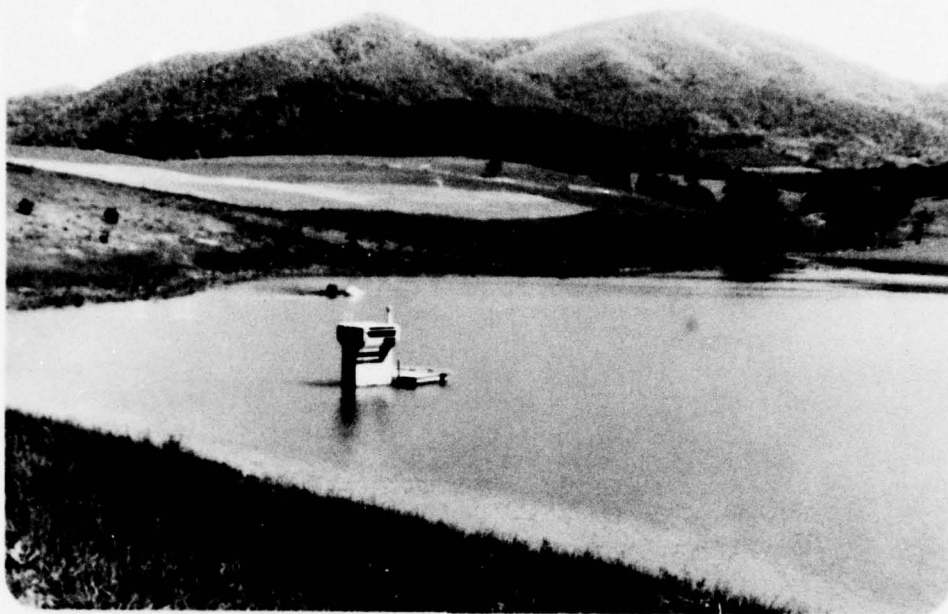
3.1.4 Appurtenant Structures: The intake structure was not inspected because the structure is only accessible by boat. Observing from a distance, the concrete structure appeared to be in excellent condition. Water was discharging through the 24-inch-diameter outlet pipe about 1/6 full. The outlet pipe and its concrete saddle were in excellent condition. The handle for the emergency gate located at the intake structure was not in place; it is stored at the landowner's premises.

PHOTO #1 INTAKE STRUCTURE

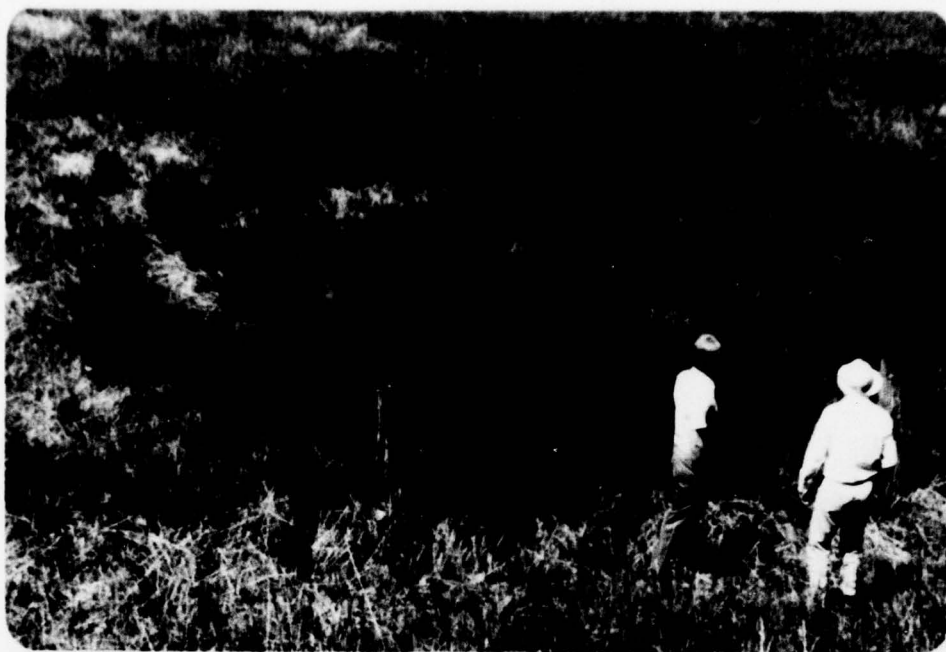
3.1.2 Embankment: All faces of the embankment were moderately covered with grasses about 8 inches tall. There were many bare spots. The ground surfaces were firm and dry except for a wet area at the downstream toe. The faces of the embankment were smooth which indicated that there were no apparent settlement or instability problems. It appeared that the internal drainage system for the embankment is working properly, as the water discharging from the two 6-inch drains (less than 1 GPM) was clear, indicating no sign of internal erosion. At normal pool, no erosion was noted at the upstream slope shoreline although no ripraps was used to protect the shoreline. A small shrub had grown on the upstream slope. Some slope sloughing was noted at the toe of the downstream slope just to the right of the outlet pipe. To the left of the outlet pipe, an area of about 50 feet square adjacent to the toe was covered with 2 to 6 inches of water, but no flowing water was observed. The whole wet area was covered with marsh grass. The ground at the toe above the wet area was also very soggy. Approximately 100 feet further downstream from the wet area, another large wet area (200 feet square) was covered with similar type of marsh grass. The ground joining the two marshy areas was soggy. Further discussion of these two areas is given in Section 3.1.6.

The undesirable conditions noted are the wet area at the toe of the downstream slope, (discussed in Section 3.1.2) and the underground spring at the left bank of the downstream channel (discussed in Section 3.1.6). With only visual inspection, it could not be determined whether the wet areas and the spring were due to seepage from the reservoir or due to natural springs which existed prior to the dam construction. Due to the fact that the geology report failed to mention any springs or swamps in the site investigation and the suspected joint system in the granite (see Section 6.1 and Appendix IV), one cannot rule out that these conditions are not caused by seepage from the reservoir. Although the situation is not a major problem at this time, the wet area and the flow rate of the spring

PHOTO #3 WET MARSHY AREA AT TOE TO
LEFT OF PRINCIPAL SPILLWAY

b. The wet area at the downstream toe and the flow of water from the hole at the downstream channel should be monitored closely (see sections 3.1.2 and 3.1.6). It could not be determined whether the wet area and this flow were due to seepage from the lake or from natural springs, which could have existed prior to the dam construction. Although the situation is not a major problem at this time, the wet area and the flow rate at the hole should be monitored closely. The flow rate should be fairly steady at normal pool condition. Any sudden change in the flow rate as well as change in water turbidity should be detected at an early stage for implementing appropriate remedial measures. The flow rate and the pool level should be recorded at the same time especially at extremely wet periods. The source of this flow and the wet area should be determined before the normal pool level is raised from the present elevation of 1273.7 feet to 1282.4 in the future.

b. The source of the wet condition at the toe of the dam should be determined and appropriate remedial measures be taken before the present normal pool is raised to the 100-year sediment pool.

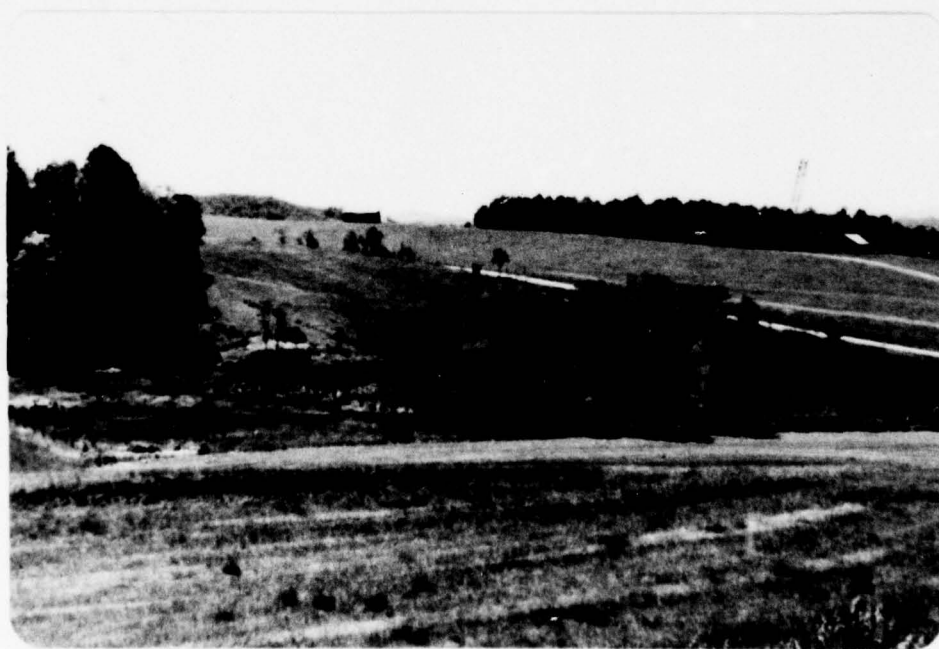
PHOTO #4 WET MARSHY AREA IN FIELD
BEYOND TOE OF DAM

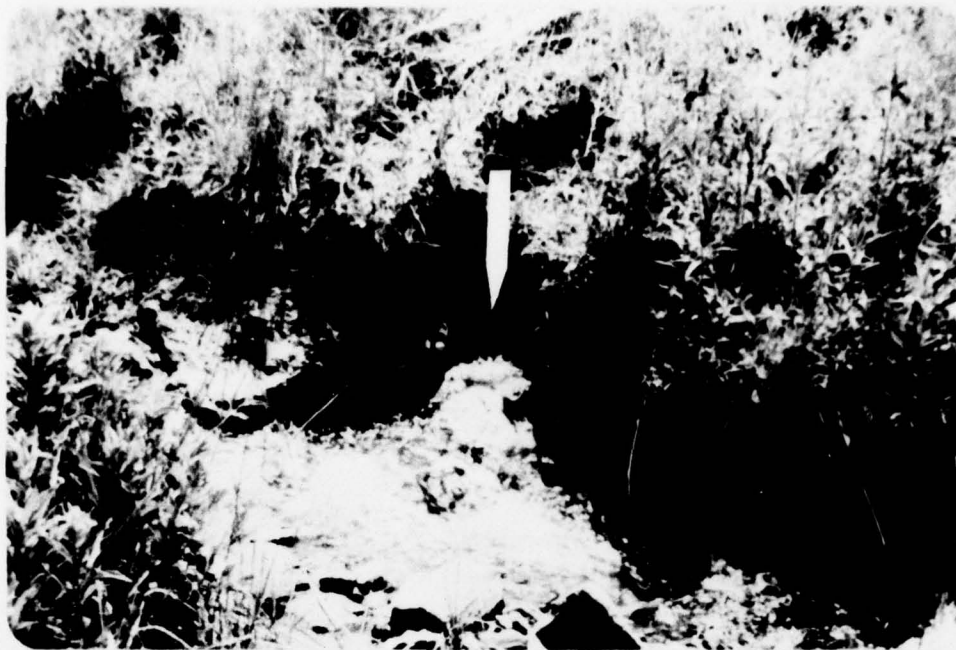
3.1.6 Stilling Basin and Downstream Channel: The stilling basin extends approximately 30 feet from the toe of dam at the outlet pipe. The banks were protected with riprap from 4 to 18-inches in size. The riprap surface appeared to be relatively even indicating that the rocks had been placed properly. Some small trees and shrubs are growing in the riprap. Water flows freely from the basin into the downstream channel which is about 4 feet wide. Both the stilling basin and the downstream channel are in good condition. About 100 feet downstream from the outlet pipe, water is flowing at a rate of 10 GPM from a 12 inch diameter hole on the left bank of the downstream channel.

It could not be determined whether the flow was from a natural spring, which also caused the wet marshy areas discussed in section 3.1.2, during the visual inspection. Four drainage pipes were found on the left bank of the downstream channel. Although all the pipes were dry, it appeared to be an attempt, as related by the landowner, to drain the marshy areas which existed prior to the dam construction. Two subterranean flows were observed in the channel which discharges into the Blackwater River.

PHOTO # 5 JUNCTION OF SUSPECTED FIELD
DRAIN AND MAIN CHANNEL

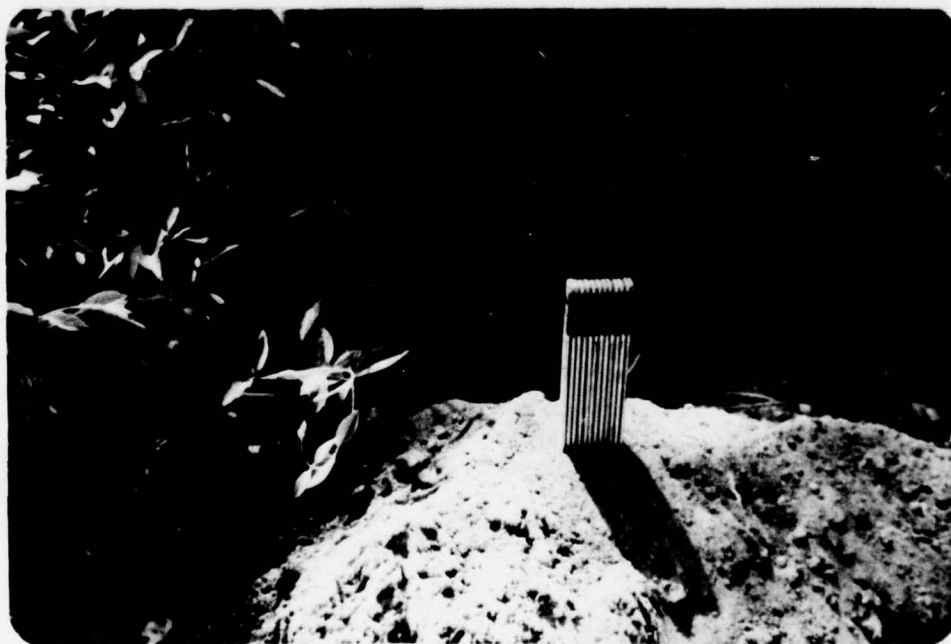
3.1.3 Junction of Embankment and Abutment: At the left junction, animal burrows as large as 12 inches in diameter were observed on both the upstream and downstream slopes. Soils at the lower section of the left junction were eroded and gullies formed up to 18 inches deep.

PHOTO # 6 TYPICAL ANIMAL BURROW AT
JUNCTION OF LT. ABUTMENT AND
EMBANKMENT

d. All gullies caused by runoff and animal burrows should be filled with compacted soils of the same type forming the face of the dam. The restored areas should be seeded to form a good grass cover.

c. All gullies caused by runoff and animal burrows should be filled with compacted soils of the same type used to form the face of the dam. The restored areas should be seeded to form a good grass cover.
